The Design and Evaluation of Injection Grouts for the Reattachment of Historic Plaster in St Mary's Church, Pöide, Estonia

Varje Õunapuu, Eesti Kunstiakadeemia (Estonian Academy of Arts)

The research was inspired by the 13th century masonry building, the St. Mary's Church in Pöide, Estonia, where the large areas of ancient interior plaster are detached and loose, and require repair. The aim was to analyze and evaluate commercial and custom-mixed grouts in order to design a grouting mixture for use with medium and large size voids, as well as to reduce the cost of materials for restoration works. During the experiments two commercial grouts, Ledan TA1 and Vapo Injekt, and also thirty-five custom grout mixtures were analyzed and evaluated. The research began by the assessment of the plaster samples from St. Mary's Church in order to set the reference data for finding compatible injection grouts. The final results of this research conclude that the three selected custom grouts are suitable and recommended for the injection grouting of medium and large size voids and cracks. They are compatible with the historic plaster of the St. Mary's Church, and can reduce the cost of materials f

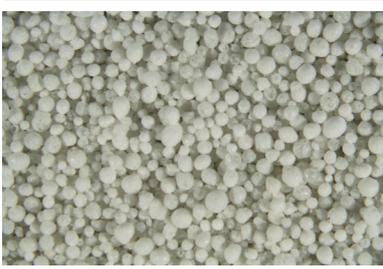
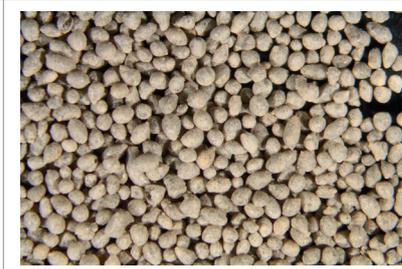
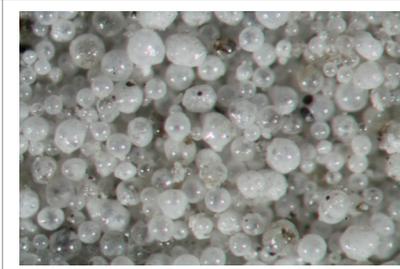
Tbl. 3 The optical microscope photographs of the three light-weight fillers used in the experiments. Photos: courtesy of Romana Rajtárová

Poraver 0,25–0,5 mm (mag. x 10)	Liaver 0,25–0,5 mm (mag. x 10)	Fillite 160 W 5–180 µm (mag. x 63)

and acrylic emulsion were chosen to improve the fluidity and water retention of the grouts. Three variations of fillers were used as aggregates in the grouts: 1) limestone powder, 2) lightweight fillers like Poraver, Liaver and Fillite 160 W, and 3) the combination of limestone powder and lightweight fillers. The lightweight aggregates were analyzed beforehand to make sure that the materials do not contain high amounts of water-soluble salts. The bulk content of water-soluble compounds, mainly soluble salts, was analyzed gravimetrically and by conductivity measurement.¹⁰ Results showed that all the tested fillers are suitable for the injection grouting due to their relatively low water-soluble content.

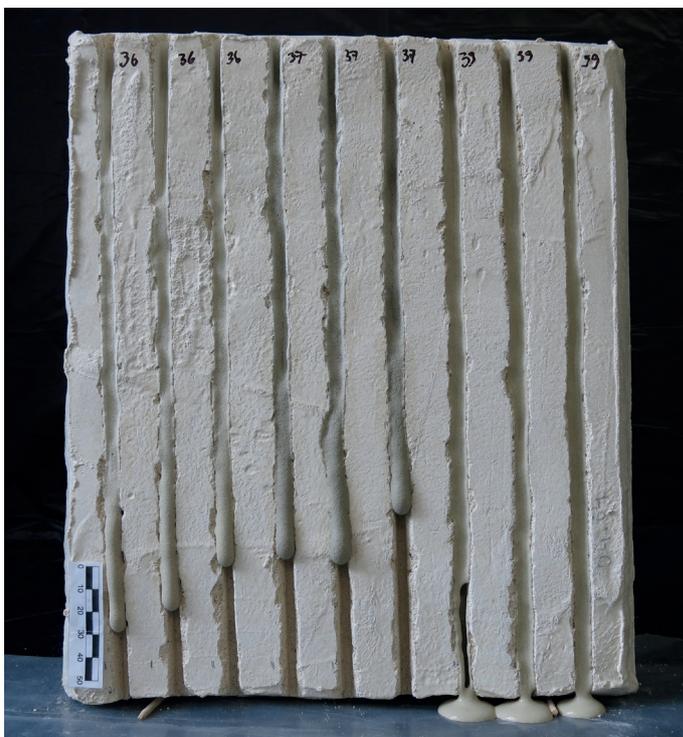
This test is an adaptation of the test described in the Getty manual on pages 75–77.¹⁵ According to the manual, the aim of this test was to compare the ability of different grouts to flow in vertical channels cut into the plaster. For this experiment Aeroc (now Bauroc) building blocks made of aerated concrete, in size of 250 x 300 x 50 mm, were covered with a 25 mm thick layer of the imitation mortar. Panels were matured in high relative humidity conditions ($T = 15 \pm 1^\circ\text{C}$; $\text{RH} = 91 \pm 1\%$) for one week, and then for approximately 8 weeks (55 days) in dryer conditions ($T = 19 \pm 1^\circ\text{C}$; $\text{RH} = 73 \pm 3\%$). After curing, 5 mm wide channels were cut in the plaster with a drywall hand saw. The space between the channels was about 15–20 mm. The depth of the channels was about 7–8 mm.

Pic. 1 Plastered panel for the fluidity test. Photo: Varje Öunapuu

To carry through the experiment the panel was placed vertically, and 5 ml of grout was injected into the top of the channel to measure the length of flow. Each grout was tested three times and the average of the results were calculated. Results were characterised by the length of flow, and were given an evaluation marks from 0 to 5 – the lowest marks were given to the grouts which flowed the longest distance, and therefore presented the best results.

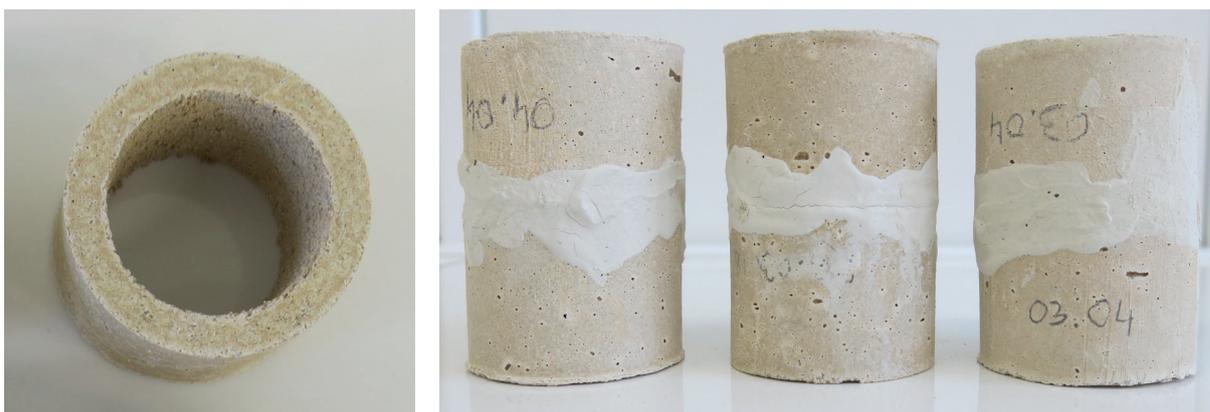
Pic. 2 and 3 Cylinders glued together with the mixture of NHL5 and water. Photos: Varje Õunapuu

The experiment with the plaster cylinders was done to observe the volume shrinkage of the grouts, as well as the adhesion between the cylinder-shaped plaster specimen and the grouts. Plaster specimens were prepared out of the mortar imitating the properties of the historic plaster. The fresh mortar, consisting of NHL5 (250 g), sand (200 g), crushed marble (50 g), and water (200 g) was put in cylinder shaped detachable casts and let to cure for a few days, until the mortar was hardened enough to be removed from the casts. The inner surface of the specimen was coarsened before it was taken out of the cast, and left to cure for 28 days. The dimensions of the cylinder casts were 40 x 40 x 5 mm. To prepare the cylinders with higher volume, two specimens were glued on top of each other with the mixture of NHL5 and water. This created 80 mm high cylinders, where shrinkage would be more visible. Each grout was injected into two cylinders. After 21 days of curing, the specimens were cut in half to evaluate shrinkage. Specimens were documented by taking photos from the top, bottom, and after cutting in half. Test results were visually evaluated and each result was given a mark from 0 to 4. Lowest marks were given to the results with the least of visible shrinkage cracks. Adhesion between the cylinder and the grout was examined with the optical and scanning electron microscope.

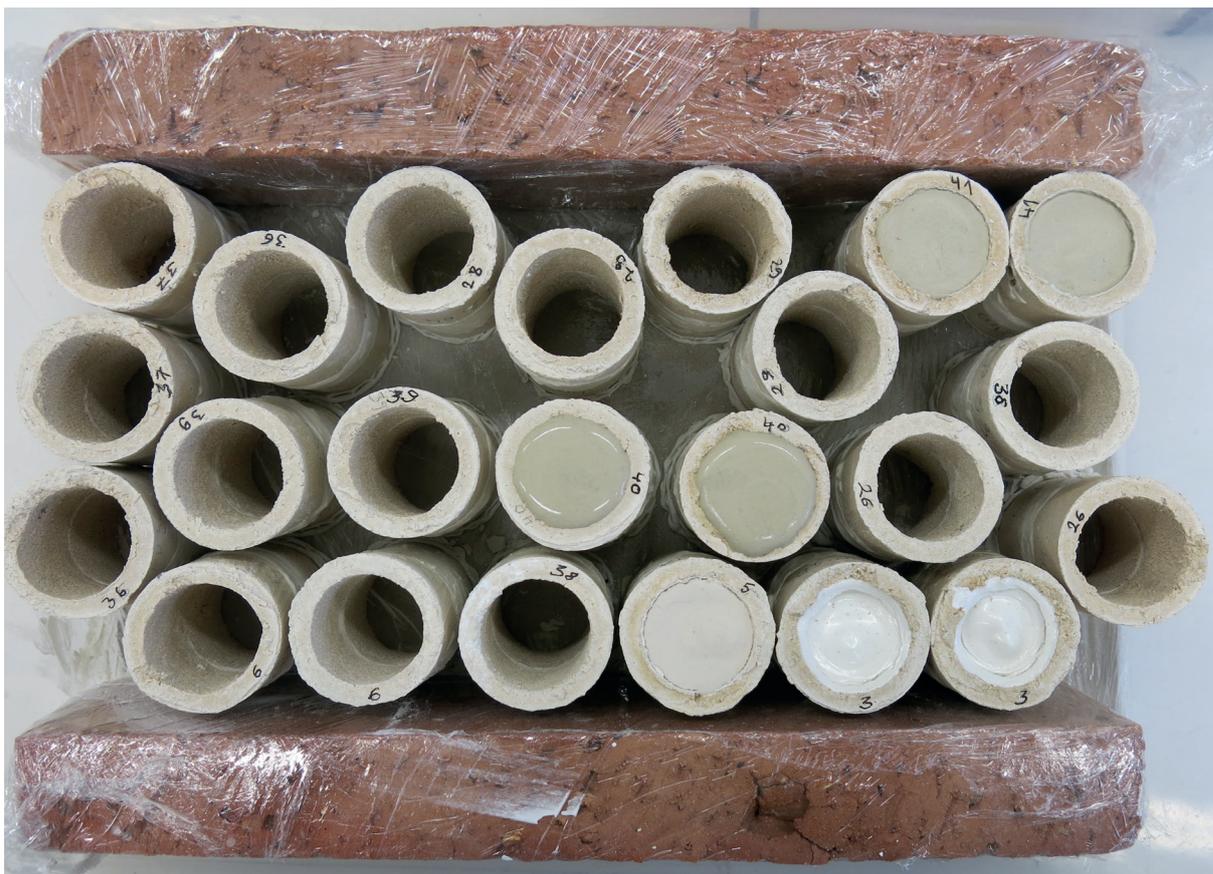
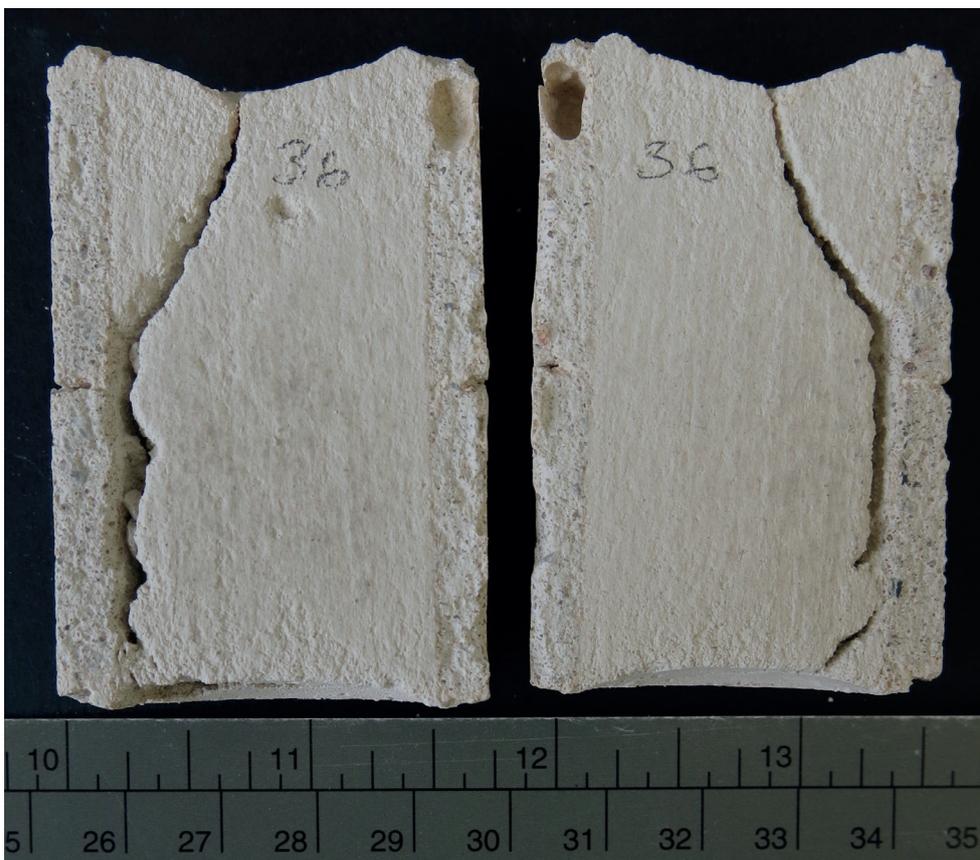
Pic. 4 and 5 Casting the grouts inside the cylinders. The cured grout in the cylinder cut in halves. Photos: Varje Õunapuu

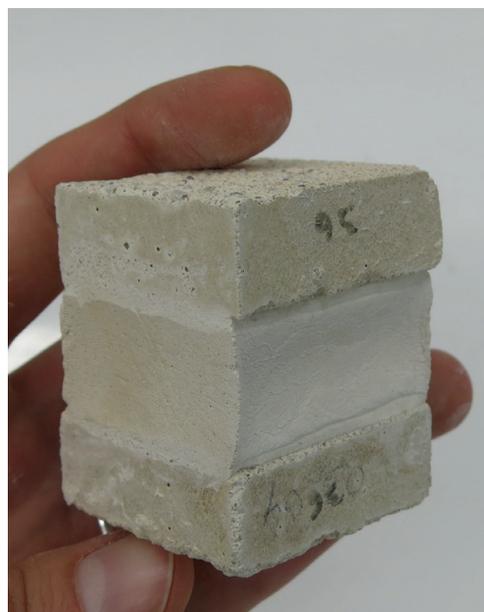
Pic. 6 Prepared test specimen for the adhesion test. Cured injection grout between two pieces of imitation mortar. Photo: Varje Öunapuu

The aim of the adhesion test was to measure the tensile strength of the selected injection grouts. Liquid grout was casted between the two specimens (40x40x20 mm) made from the imitation mortar. Cast samples matured in the humid conditions ($T = 15 \pm 1^\circ\text{C}$; $\text{RH} = 91 \pm 1\%$) for seven days and were then moved to the less humid conditions ($T = 19 \pm 1^\circ\text{C}$; $\text{RH} = 73 \pm 3\%$) for another 21 days. After 28 days solvent exchange drying method was applied to stop the hydration in the specimens. Samples were placed in a plastic container, soaked in isopropyl alcohol ($\text{C}_3\text{H}_8\text{O}$), and tightly sealed for two days. After two days, samples were removed from the solvent and left to dry in the laboratory ventilation hood until the solvent was evaporated. The time of evaporation varied depending on the size of the samples. Specimens were stored in airtight conditions until the measurements were carried out. The adhesion test was performed according to the standard ISO 4624:2016 or ČSN 73 2577. With the measurement device: FPZ100/1, VEB Thüringer Industriewerk, Rauenstein, loading with crosshead speed 2,1–64 mm/min. The test was applied only to the three selected grouts to control the adhesive capacity, and therefore evaluation marks were not given.
